**RENOVATION OF THE KHANDEK
INTERMEDIATE SCHOOL
UNDER THE ECONOMIC SUPPORT FUND PROGRAM
YOUSEFIYA, IRAQ**

SUSTAINMENT ASSESSMENT

**SIGIR PA-08-136
APRIL 21, 2009**

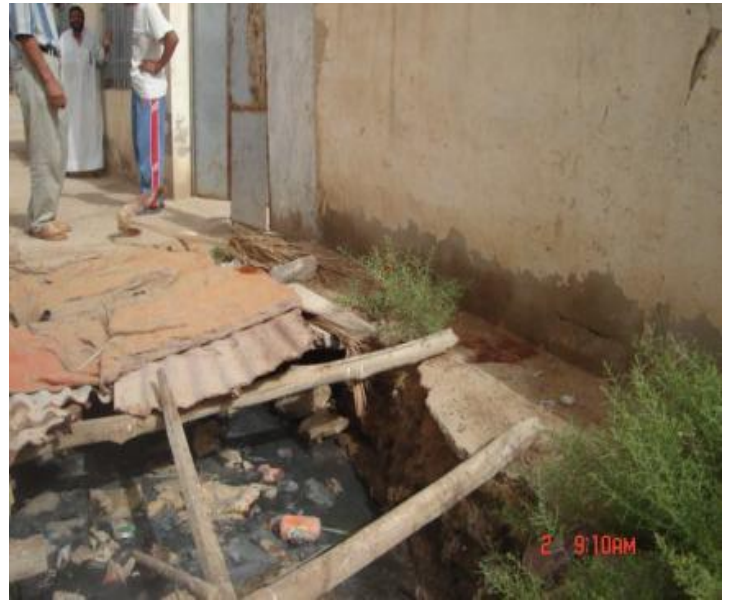
toilets showed a severe lack of maintenance, with some completely blocked with debris. The uncovered septic tank was full of sewage and debris, creating a significant health hazard, especially to the young children.

**Site Photo 1. Open septic tank
(Courtesy of GRC)**

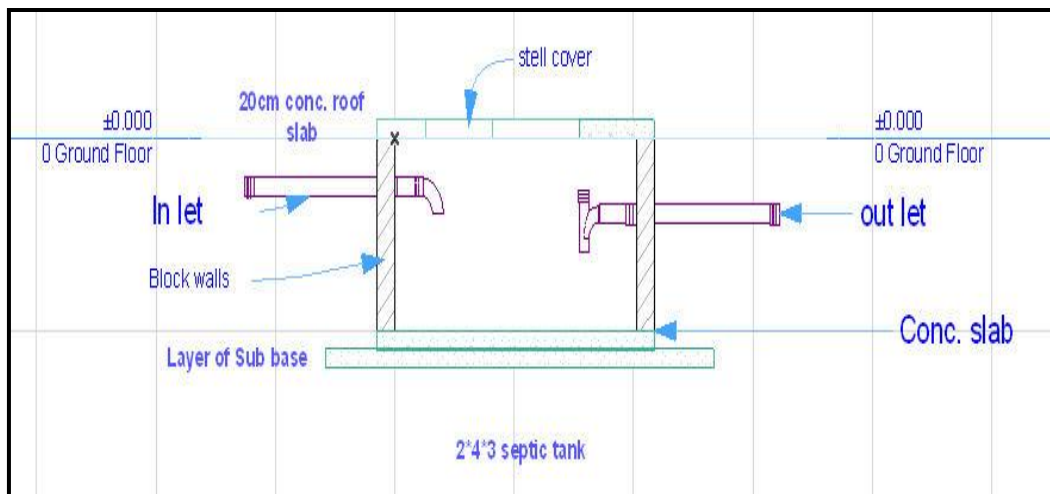
Figure 2. Septic tank section (Courtesy of GRC)

The septic holding tank indicates that the outlet of the tank flows to an absorption area. The location and configuration of the absorption was not indicated in the design. It is unclear if this system is intended to treat sewage and promote absorption into the soil, or if the tank(s) function as holding tanks to be pumped out on a regular basis.

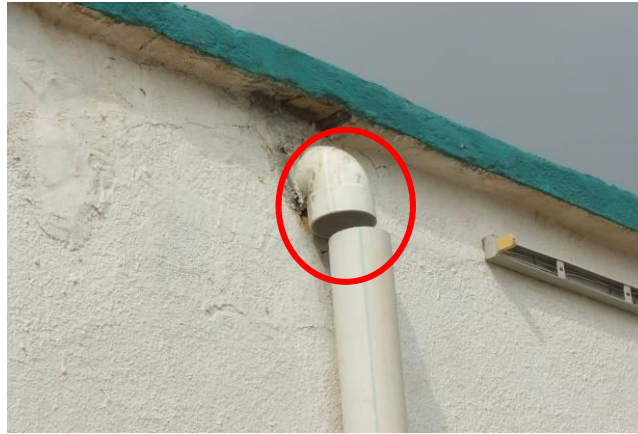
SIGIR did observe one downspout was disjointed from the roof scupper (Site Photo 5). Since this was located in a new construction area, it may have been caused by ongoing construction activities. However, due to the ease of separation of the downspout, it appears that the joints were not solvent welded. In addition, splash blocks or extensions were not provided to direct runoff away from the foundation.

Site Photo 5. Loose connection

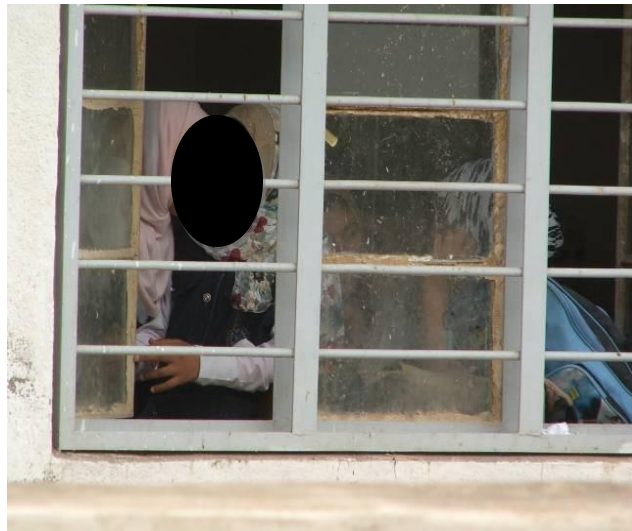
The new steel exterior doors and hardware were installed and functioning. The window glazing appeared to be in-tact. The windows have been painted and latching hardware has been installed. SIGIR did not observe any of the BOQ required window screens (Site Photo 6).

Site Photo 6. Missing window screen

1. Ensure that the cracking and deflection of the reinforced concrete beam along the front of the new restroom facility does not present a safety hazard.
2. Anchor the water-supply pump to a support and enclose wiring to the potable water-supply pump in conduit.
3. Provide the window screens required in the contract.

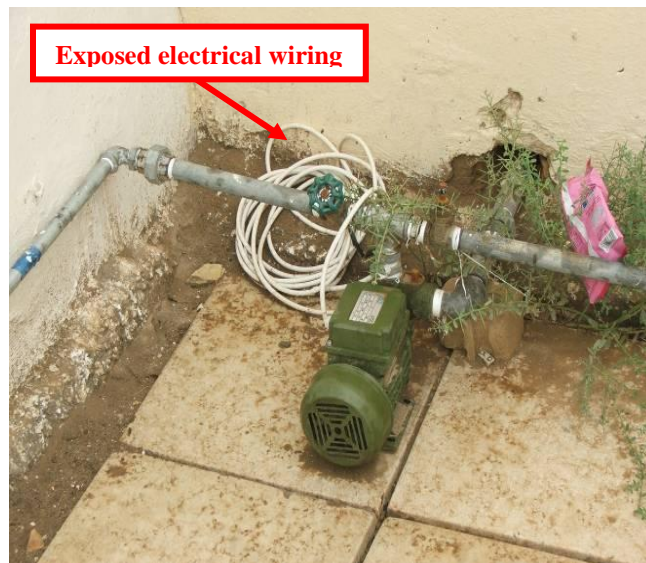
The school has two exterior restroom buildings – one existing latrine toward the rear of the school and a newly constructed second latrine toward the front of the school (part of this contract). The existing restroom was renovated with galvanized metal reservoirs installed on top. A small electric pump supplied public water to the rooftop reservoirs (Site Photo 7). SIGIR noticed the pump was not anchored to a support and the electric wiring supplying the pump's power was not placed in conduit. Consequently, the pump and wiring are constantly exposed to the elements.

Site Photo 7. Supply pump

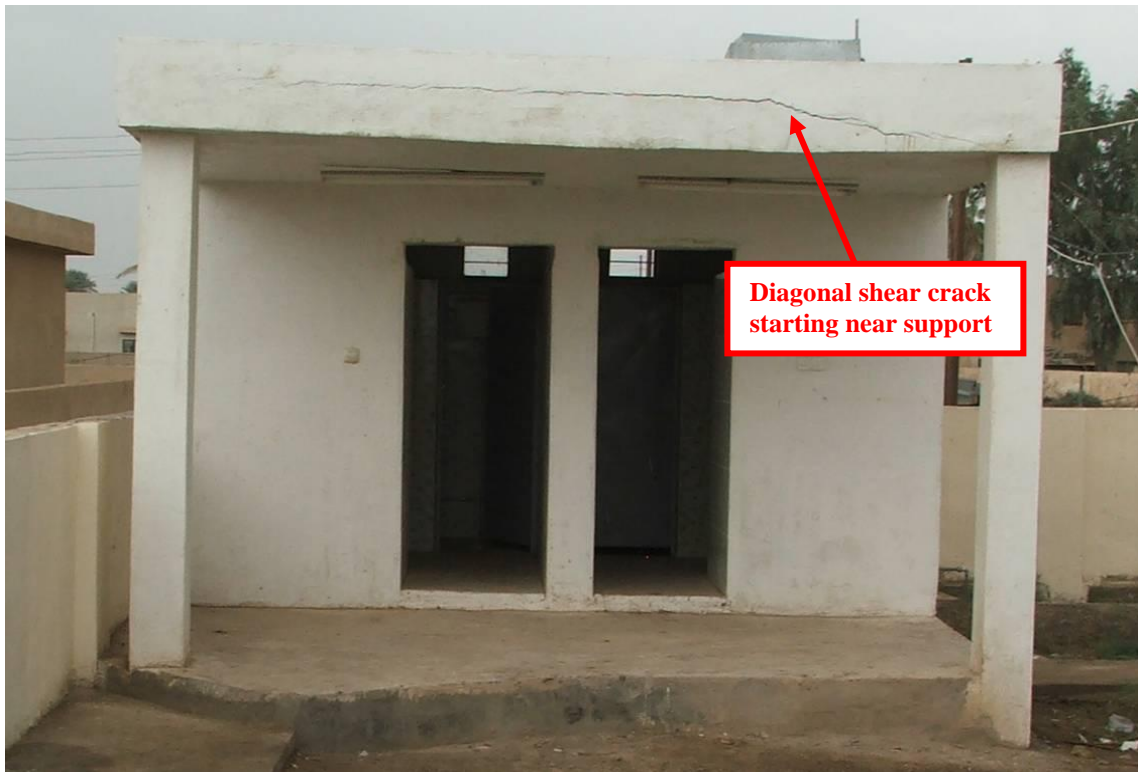
A new septic tank was constructed along with the new latrine. SIGIR identified a significant shear crack in the main beam along the front edge of the roof on the new latrine building (Site Photo 8).

Site Photo 8. New latrine building with significant shear crack

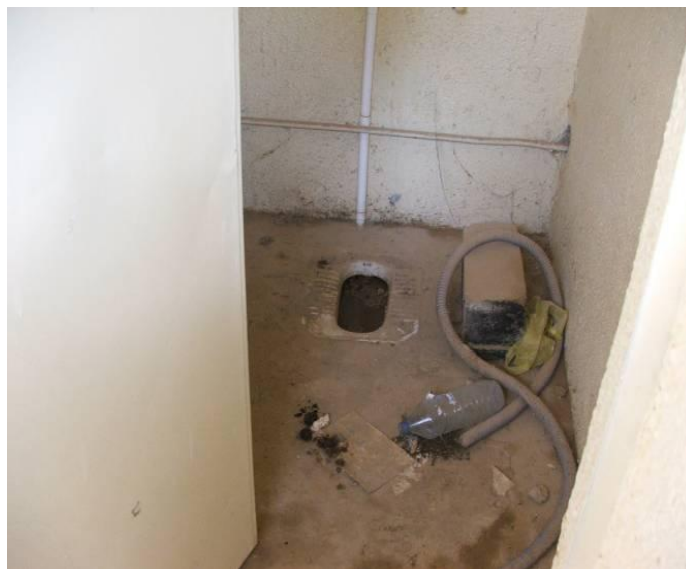
The restrooms in both latrines contained eastern-style toilets (Site Photo 9) with wall hung water tanks. At the time of the site visit, water service was not available to either latrine building; therefore, SIGIR could not verify the operability of the plumbing fixtures. Even though water was not available, the toilets were still being used. This resulted in blockages to the sanitary sewer and standing water in the toilets, resulting in unsanitary conditions for the school children.

Site Photo 9. Condition of the eastern-style toilet

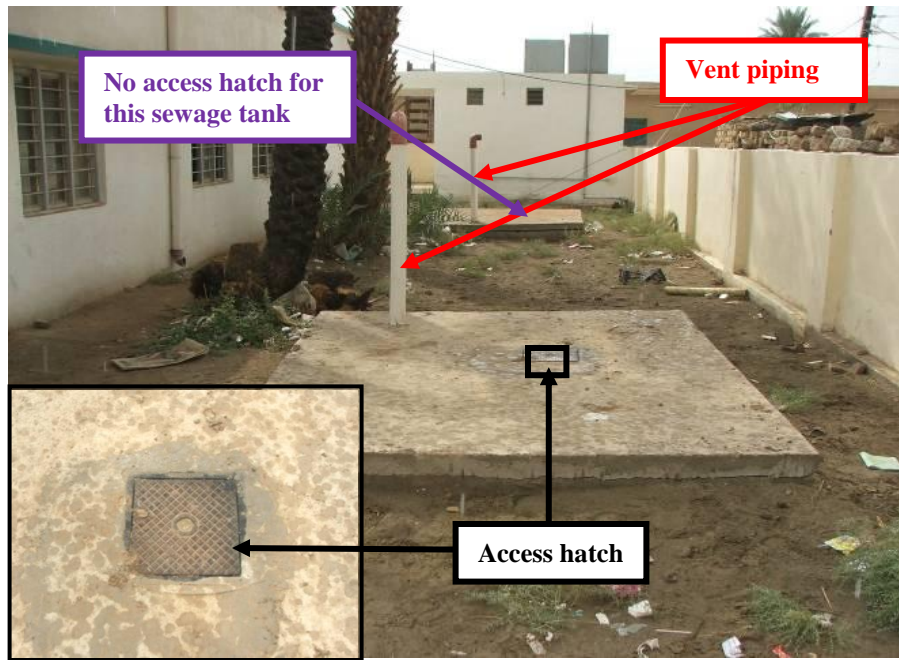
Two septic tanks were constructed on the site to service the two latrines (Site Photo 10). Vent piping was installed in the top slab of the tanks. SIGIR examined the tanks' top slabs, which did not exhibit any cracking or signs of failure; however, there was moderate curling of the top slab. A small access was provided for one of the tanks, which could be used for inspection and pumping; however, there was no access provided for the second tank. SIGIR believes this presents the school with future maintenance problems, since the school will be unable to fully empty the tank and residue will accumulate at the tank's bottom.

Site Photo 10. Septic holding tanks and tank access for one (lower left corner)

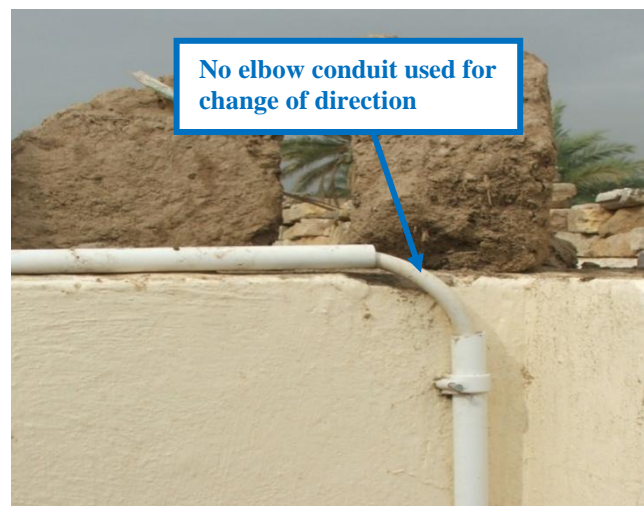
A new main circuit breaker, lights, and ceiling fans were installed in the classrooms (Site Photos 11). At the time of the site visit, the school was operating without power; therefore, SIGIR was unable to verify the operability of the electrical system. It appeared that all wiring was in conduit; however, exterior wiring did not use elbows at changes in direction (Site Photo 12).

Site Photo 12. Exterior conduit

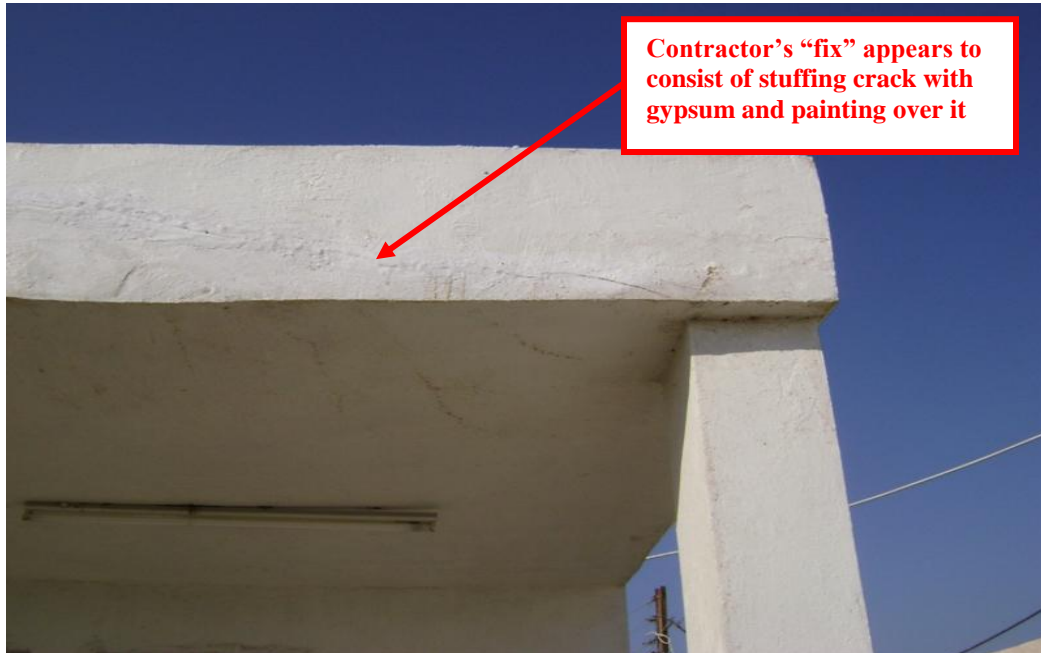
During its site visit, GRC representatives stated that the crack in the concrete beam was "currently being worked" by the contractor. GRC representatives took a photograph of the contractor's corrections, which appeared to be stuffing the crack with gypsum and then painting over it (Site Photo 13). GRC representatives did not ascertain the depth of the crack.

SIGIR does not believe the contractor's "fix" is adequate. The depth of the crack needs to be determined in order to identify the most appropriate correction.

Site Photo 13. Contractor's fix for the reinforcement beam crack (Courtesy of GRC)

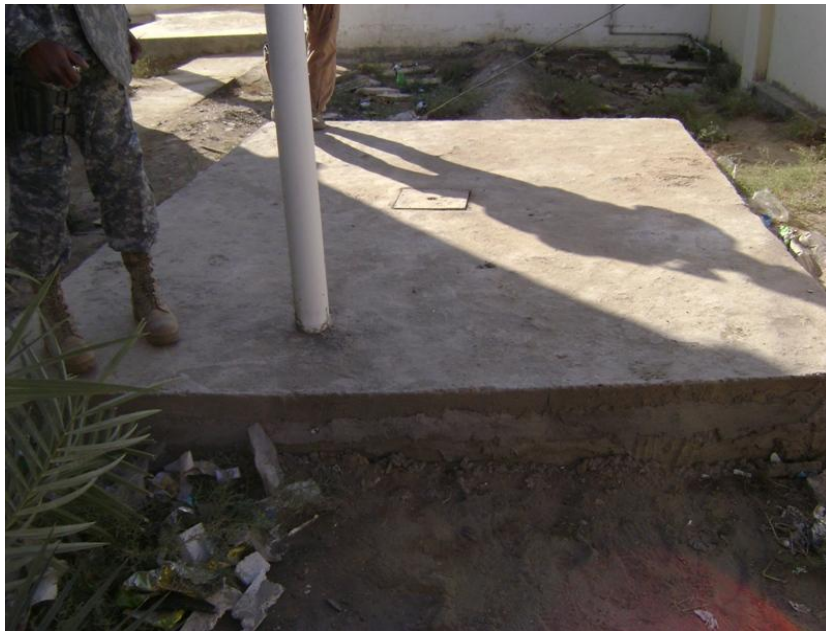
The contractor agreed to install an access hatch for the new sewage tank. GRC representatives verified that the contractor did install an access hatch (Site Photo 14). This access hatch will allow the school to periodically empty the tank so that residue will not accumulate at the tank's bottom.

Site Photo 14. Newly installed access hatch for the sewage tank (Courtesy of GRC)
